260-IN.-DIA MOTOR PROGRAM

FINAL REPORT
FOR MOTOR 44-SS-4

Contract NAS3-7970

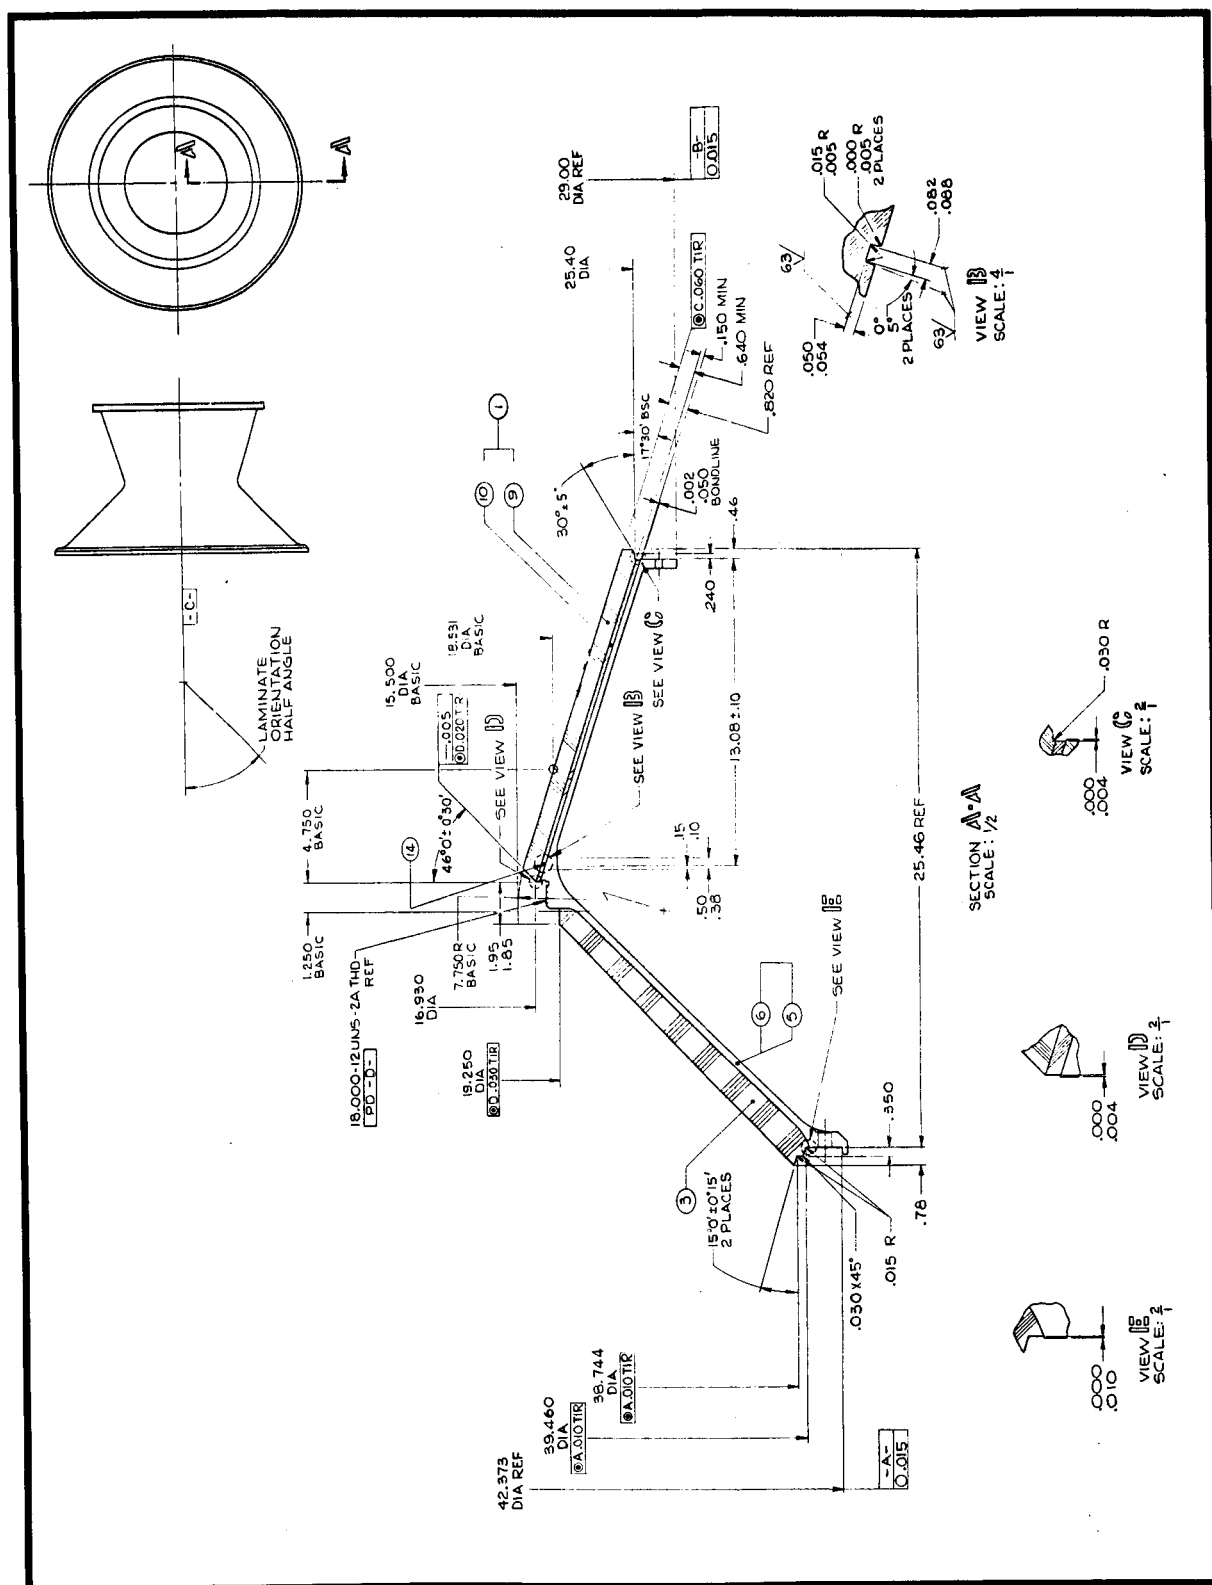
Figure 4

Nozzle Shell Insulation

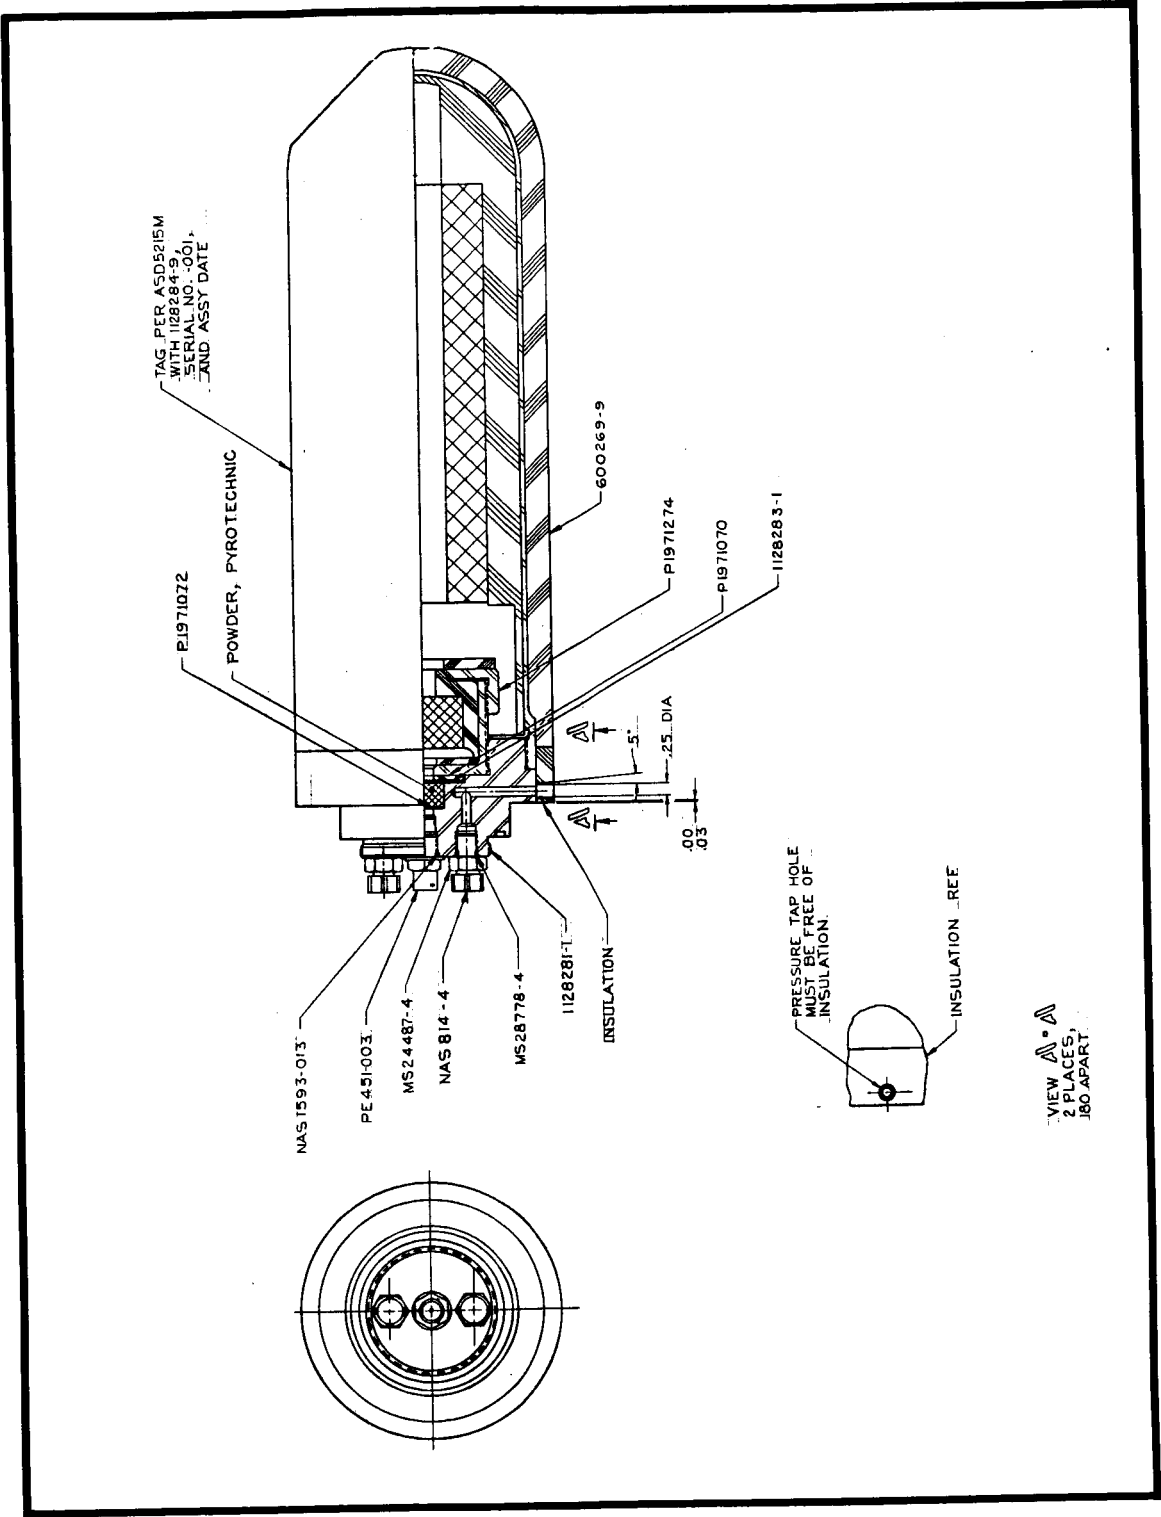
Figure 5

Igniter Assembly

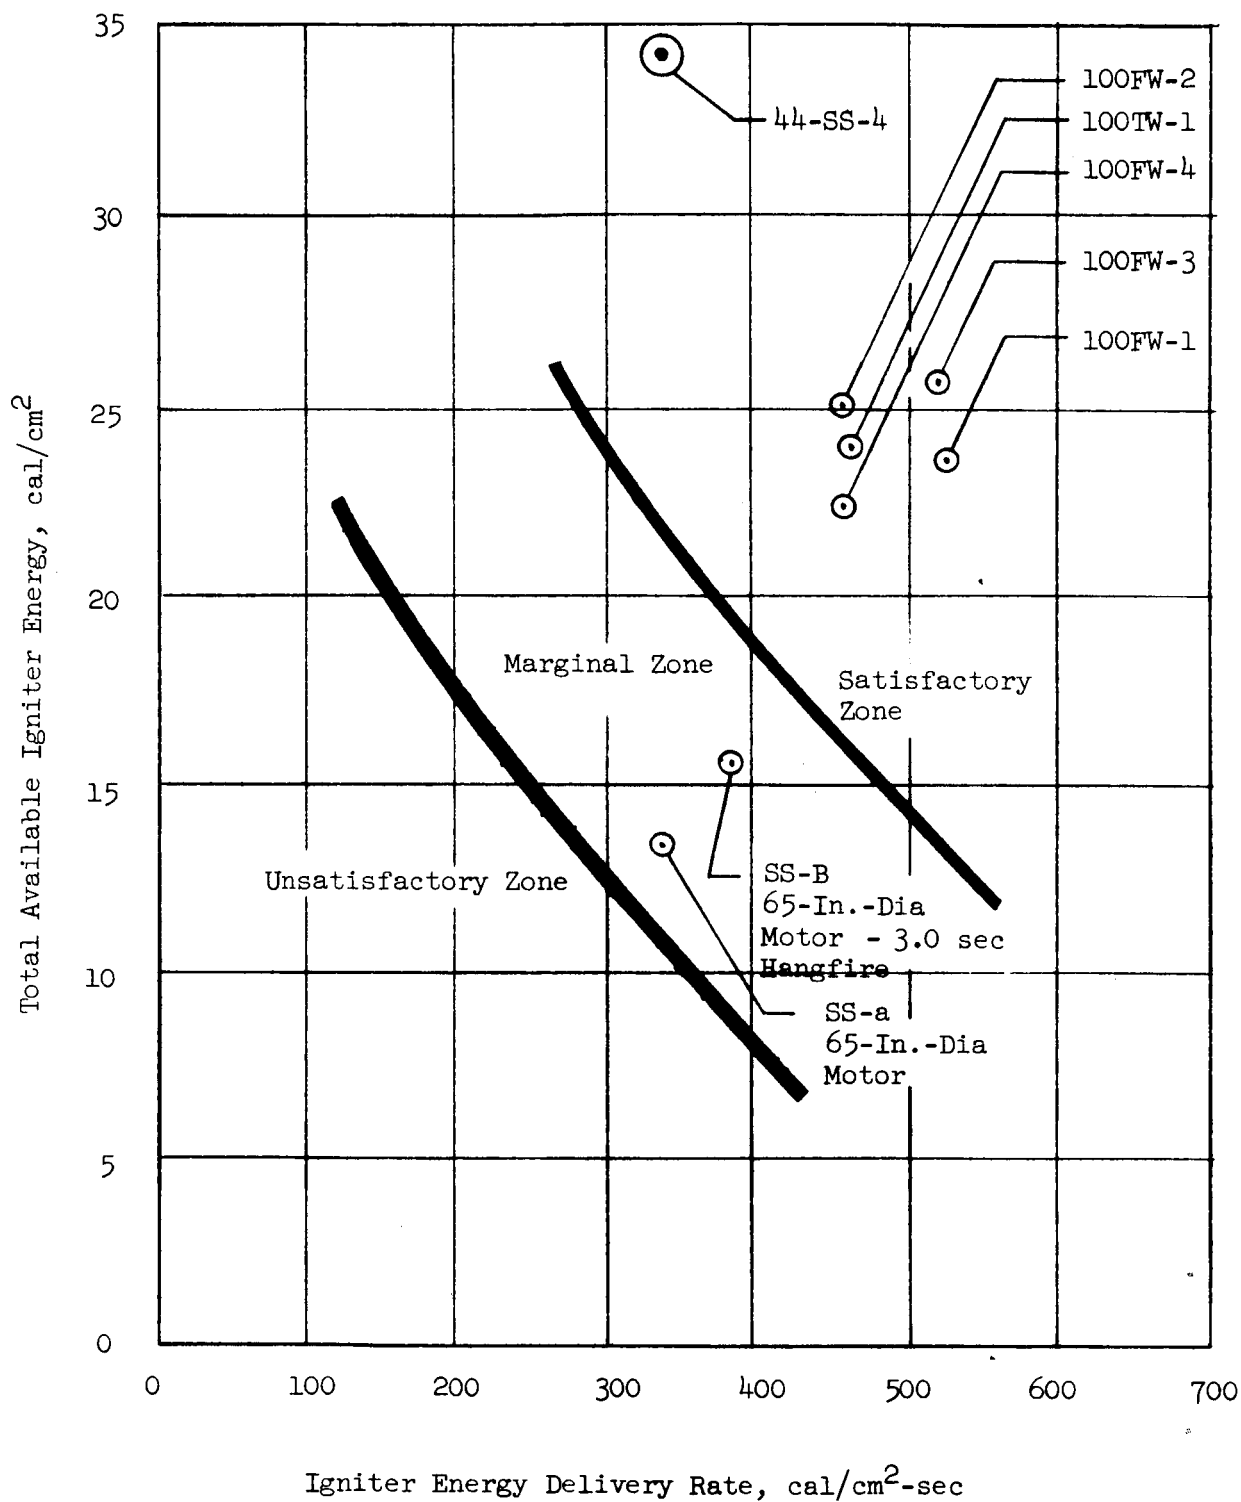
Figure 6

Empirical Correlation of Igniter Energy Release Rates
for Various Motors

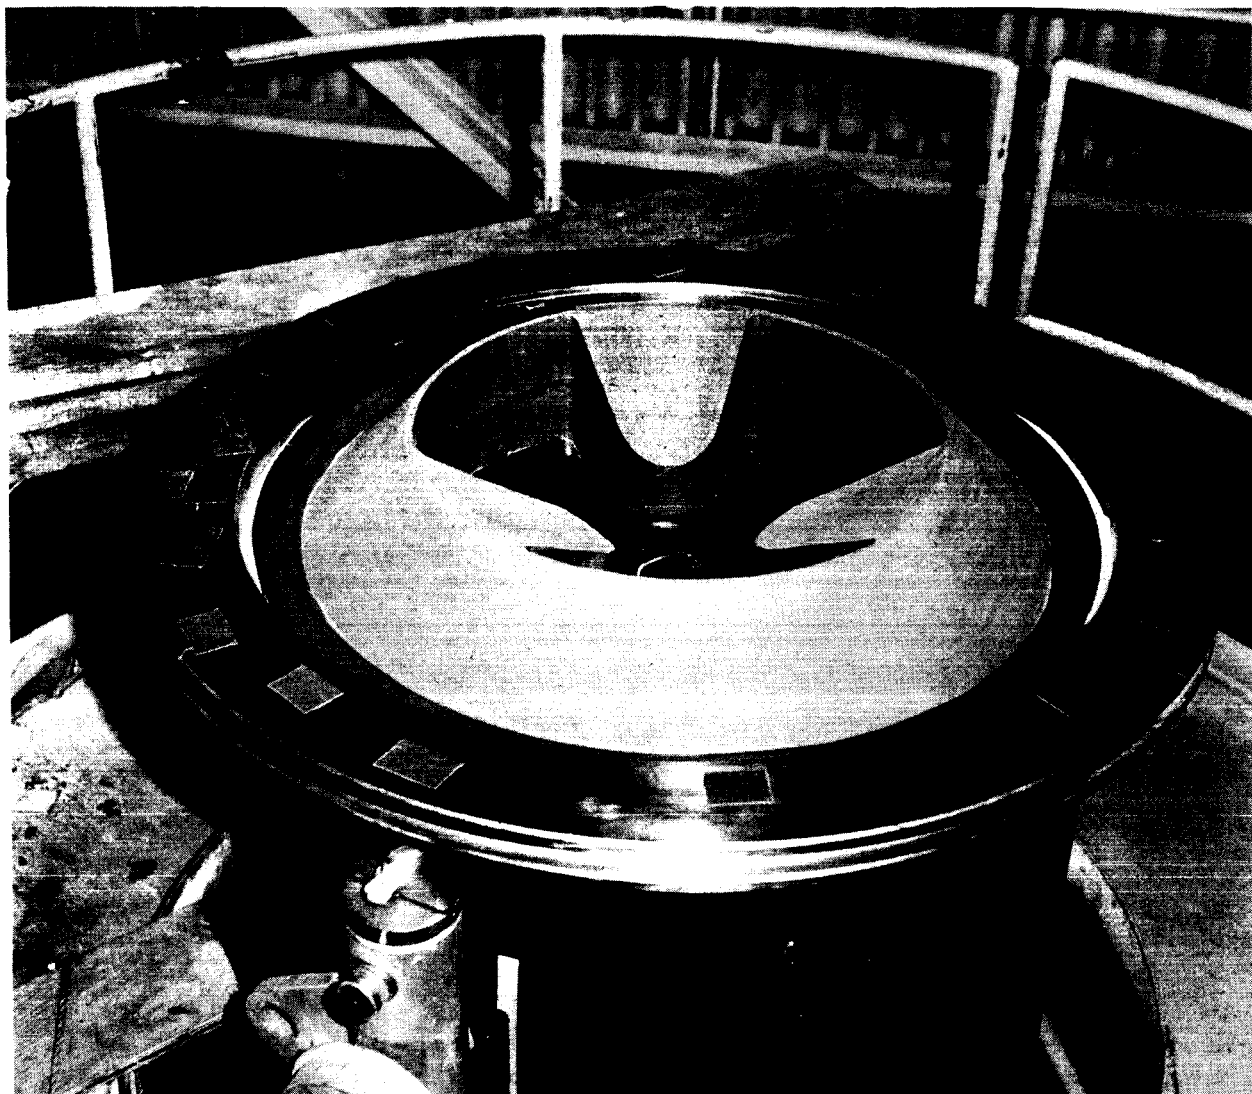
Figure 10

Trimmed Propellant Grain, 44-SS-4

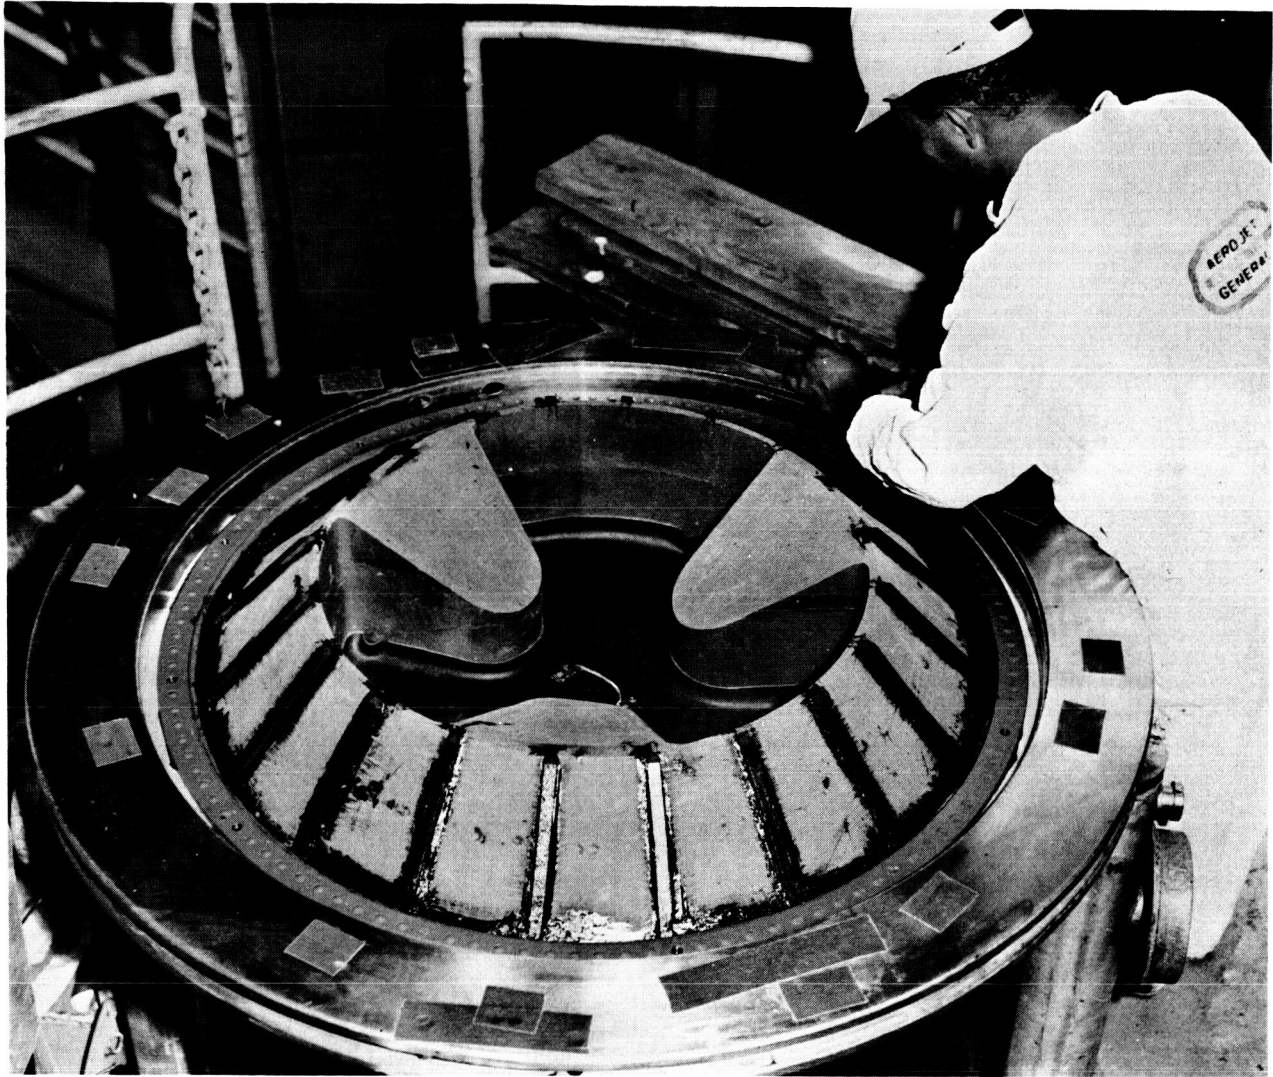
Figure 11

IBT-106 Guide Strips on Aft-Grain Face

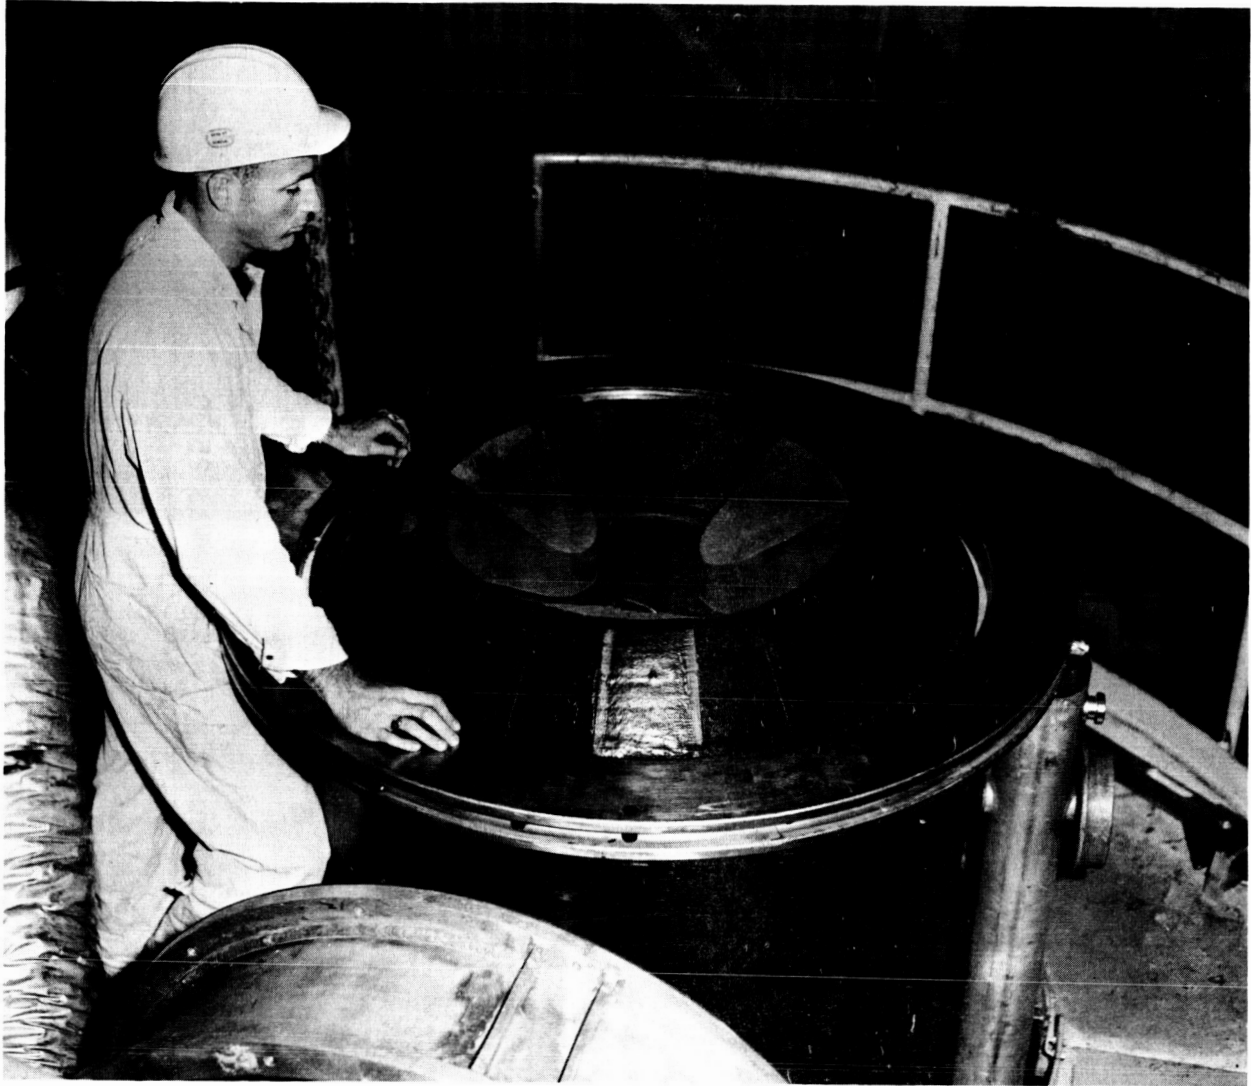
Figure 13

44-SS-4 Grain After Completion of IBT-106 Application

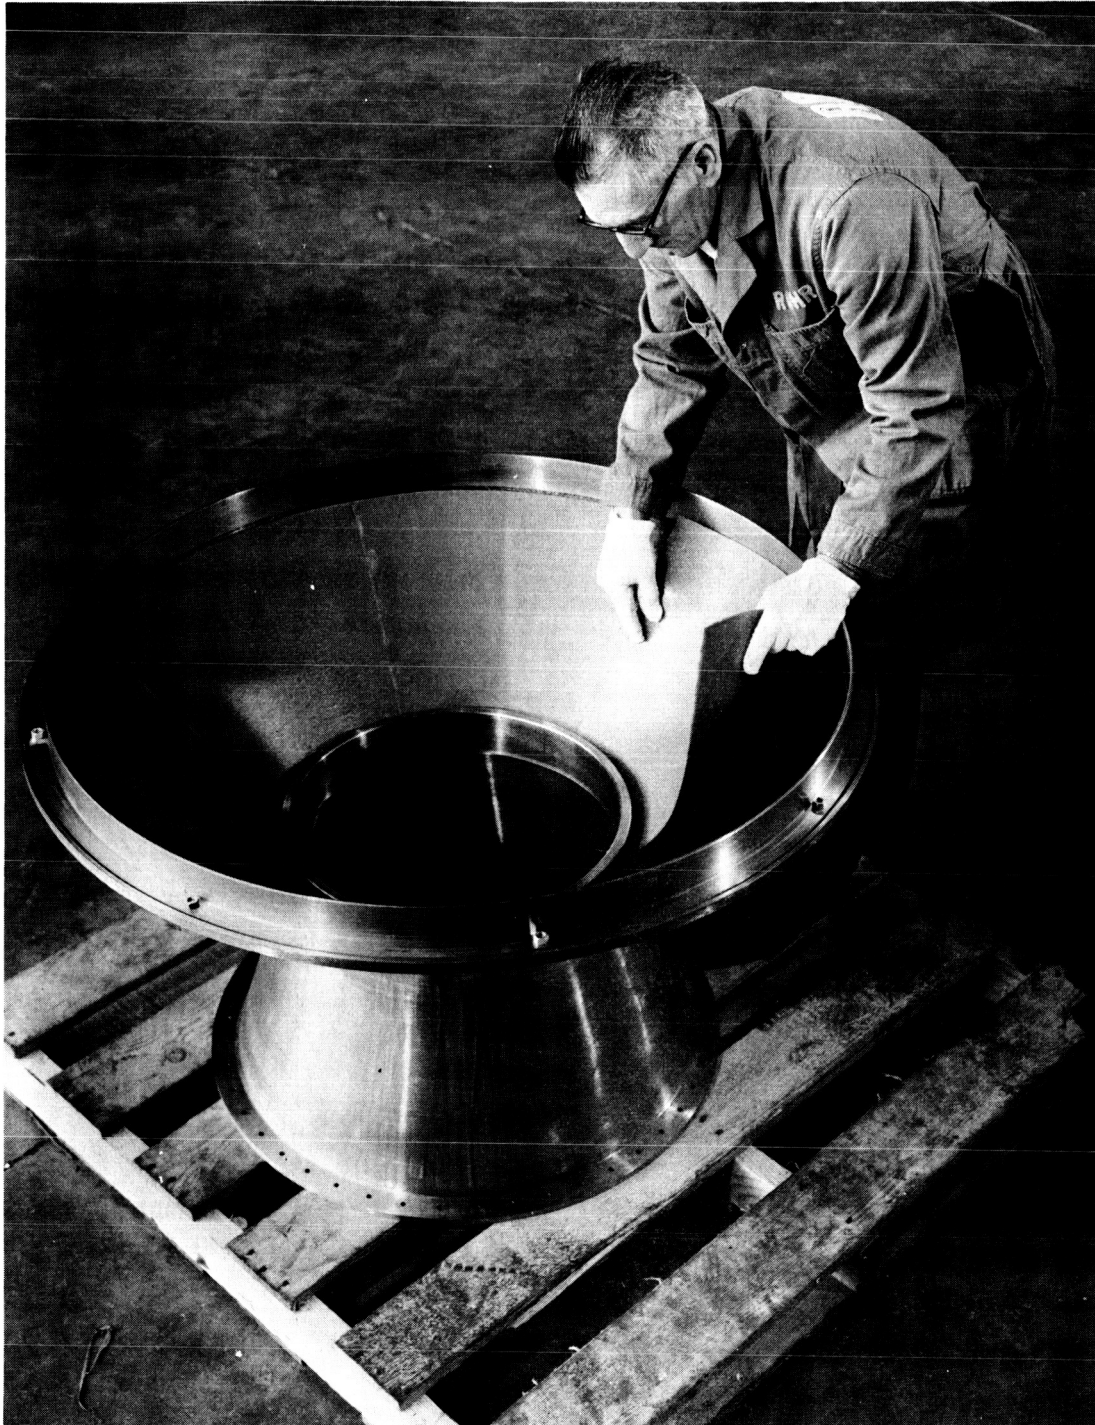
Figure 15

44-SS-4 Nozzle Rubber Insulation Lay-Up

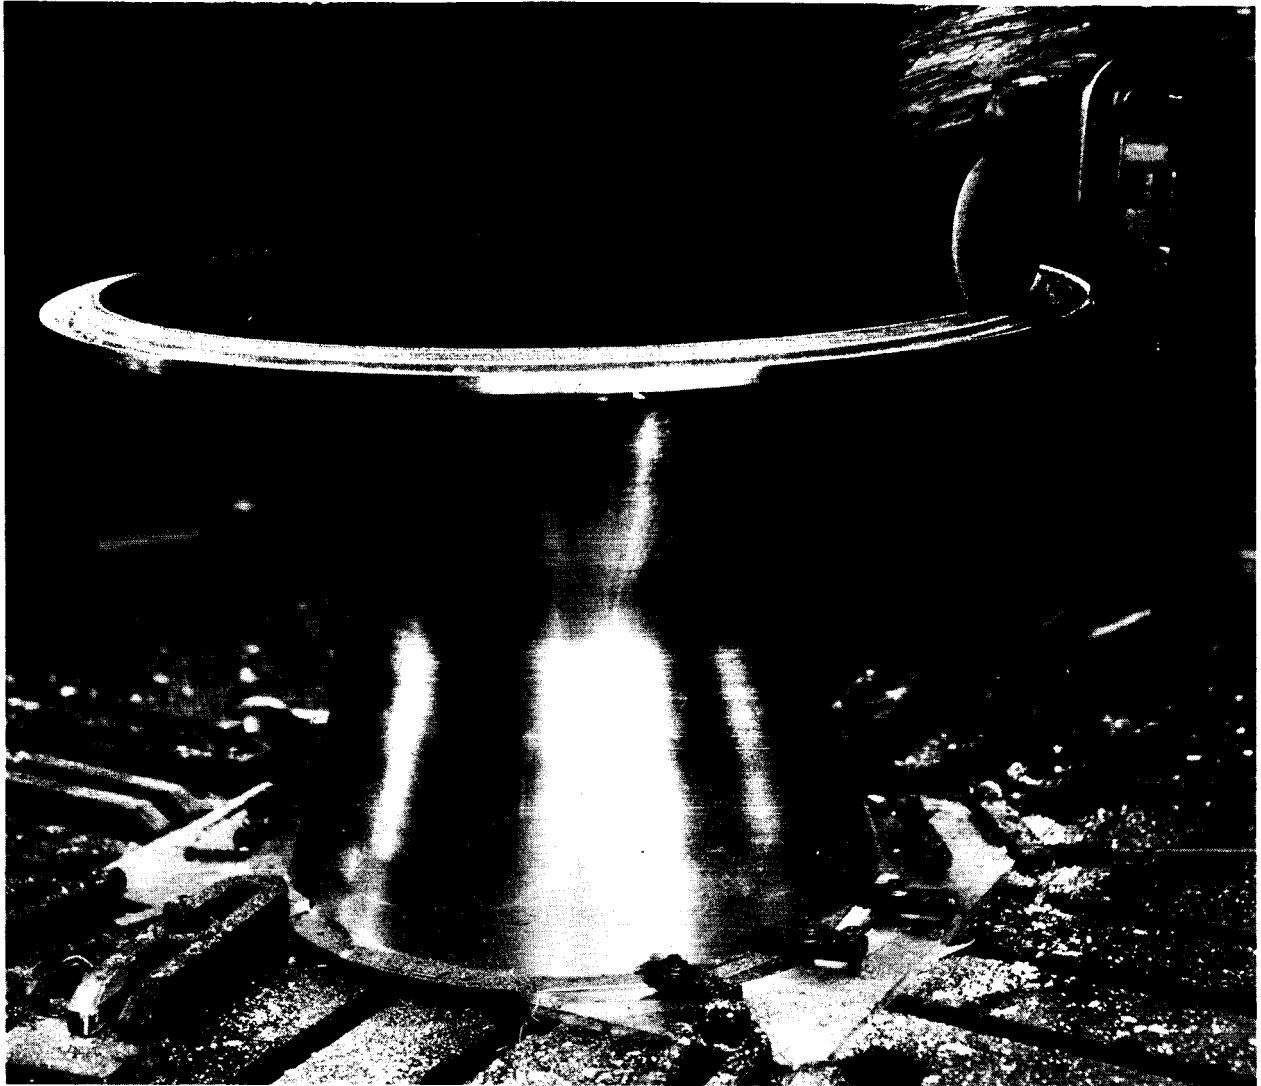
Figure 16

Throat Extension Insert Preparatory to Machining Overwrap

Machining of the entrance insulation and the mating surfaces of the shell insulation concluded fabrication operations on the insulation, as shown in Figure 16. No exceptions to the requirements of Aerojet Drawing 1127945, Nozzle Entrance Assembly, were reported. A small void located at the step joint of the shell insulation was filled using the repair method of Specification AGC-36420, Paragraph 3.4.4.2.3. The 0.78 dimension of Aerojet Drawing 1127944, Nozzle Shell Assembly, on the leading edge of the step-joint was rounded off to an undersize condition as reported on SDAR 34319.

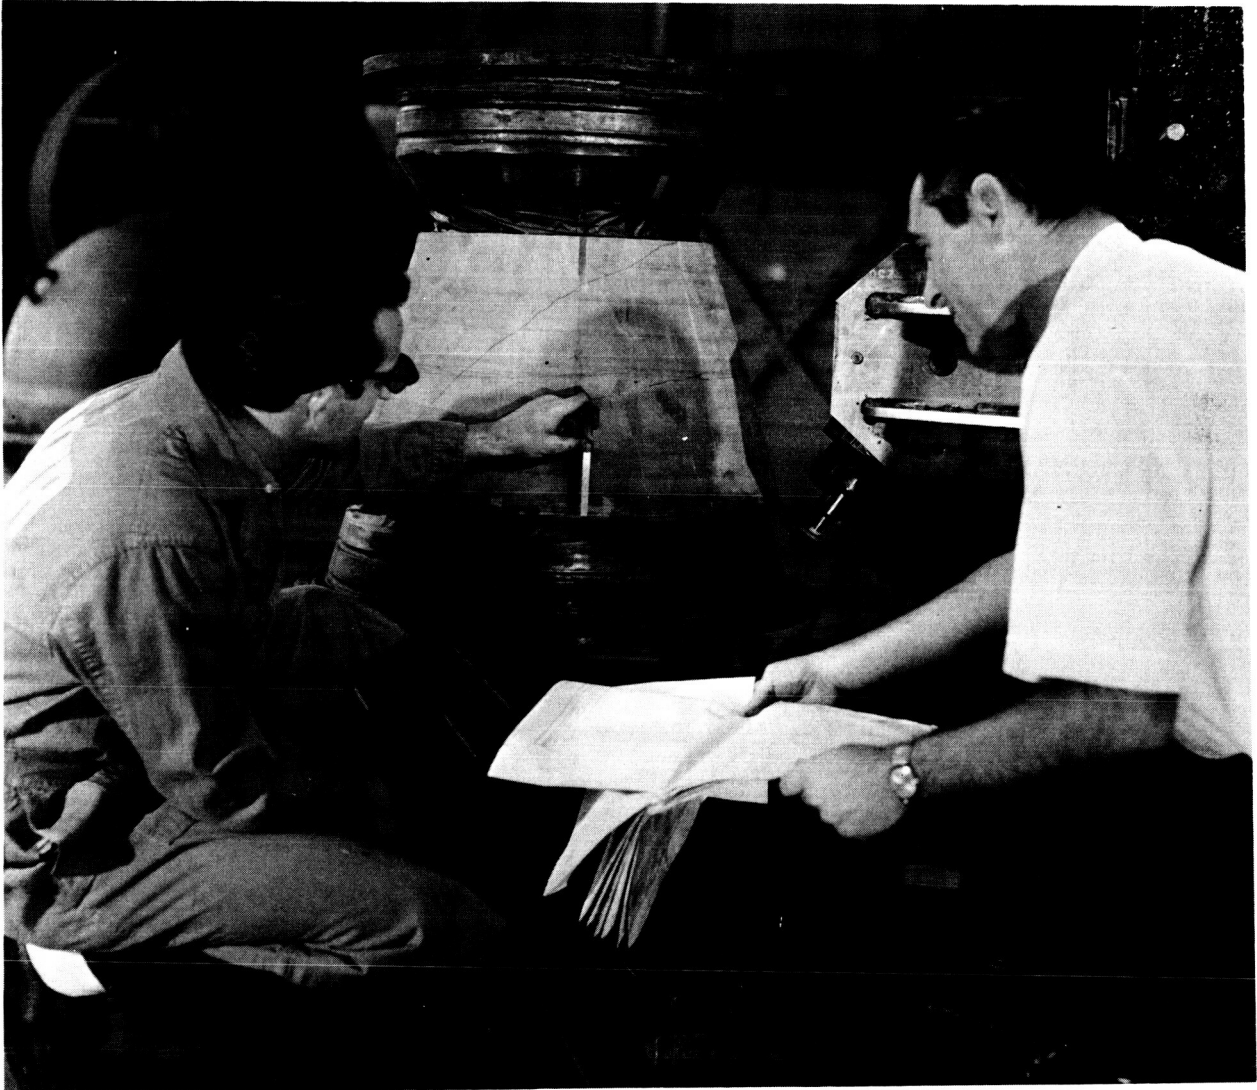
Figure 17

Machining of Submerged Insert

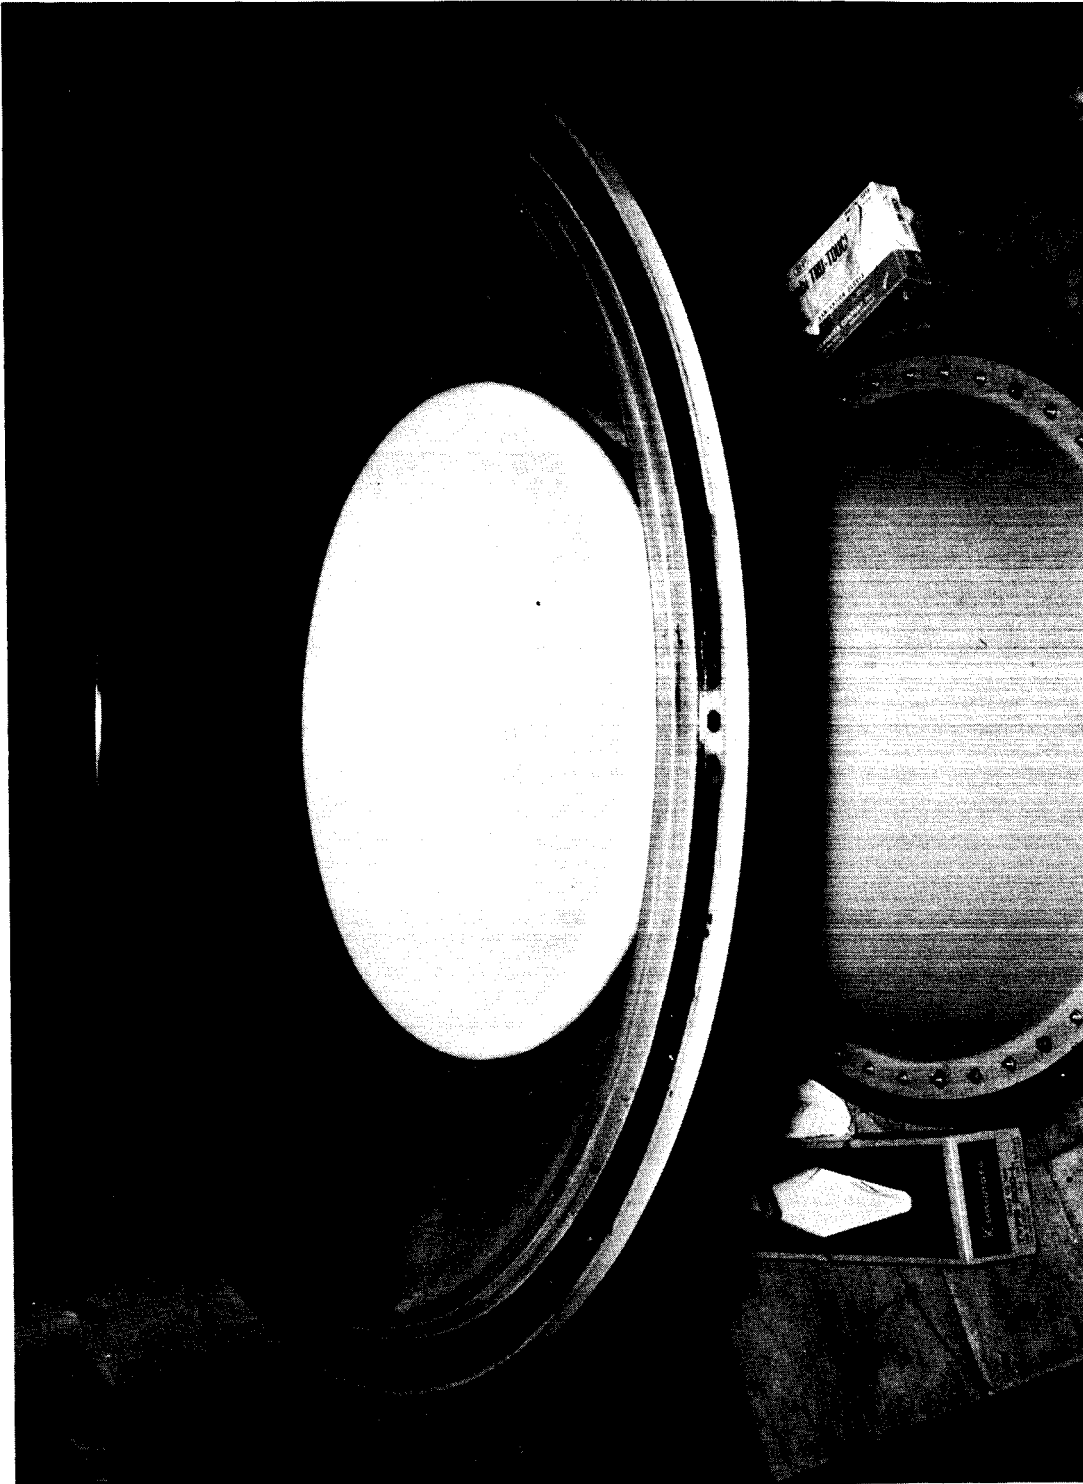
Figure 20

Completed 44-SS-4 Nozzle Assembly

Final machining of the entrance contour was accomplished after completion of bonding of the entrance assembly components. Leak testing of the inserts and the final assembly was accomplished with a helium leak detector (in lieu of the specified halogen leak test) because of halogen indications originating from uncured components of the silicone rubber potting in the ablative joints. No leakage was detected. The nozzle assembly is shown after completion of fabrication in Figure 20.

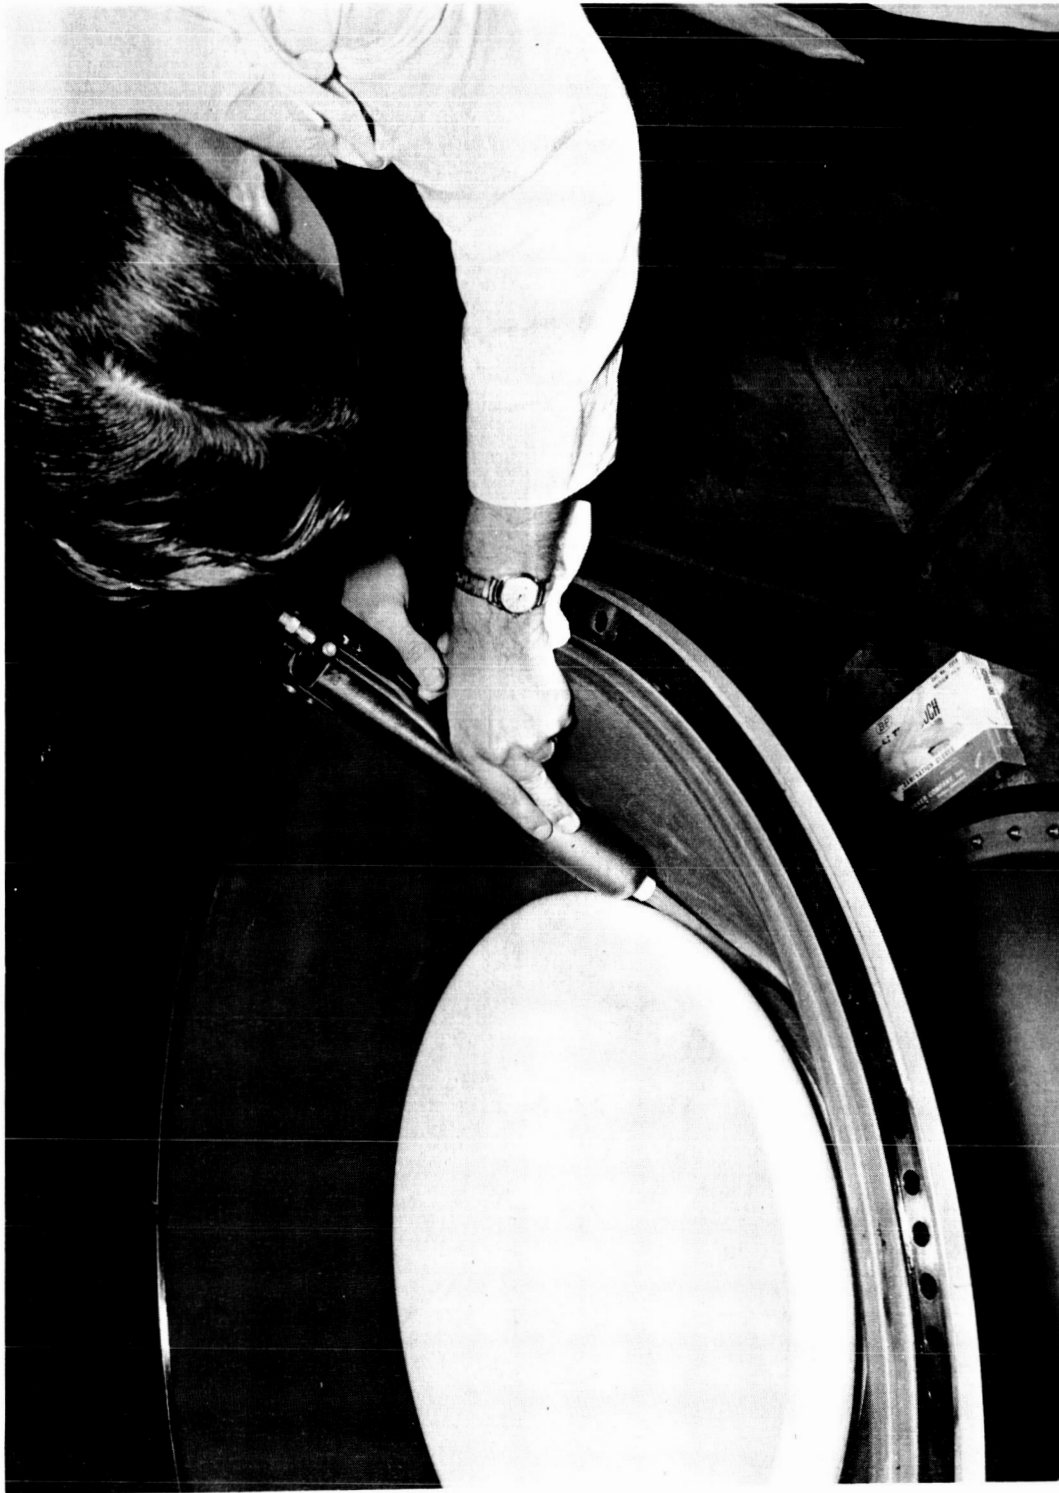
Figure 21

Application of IBT-100 Insulation to Nozzle

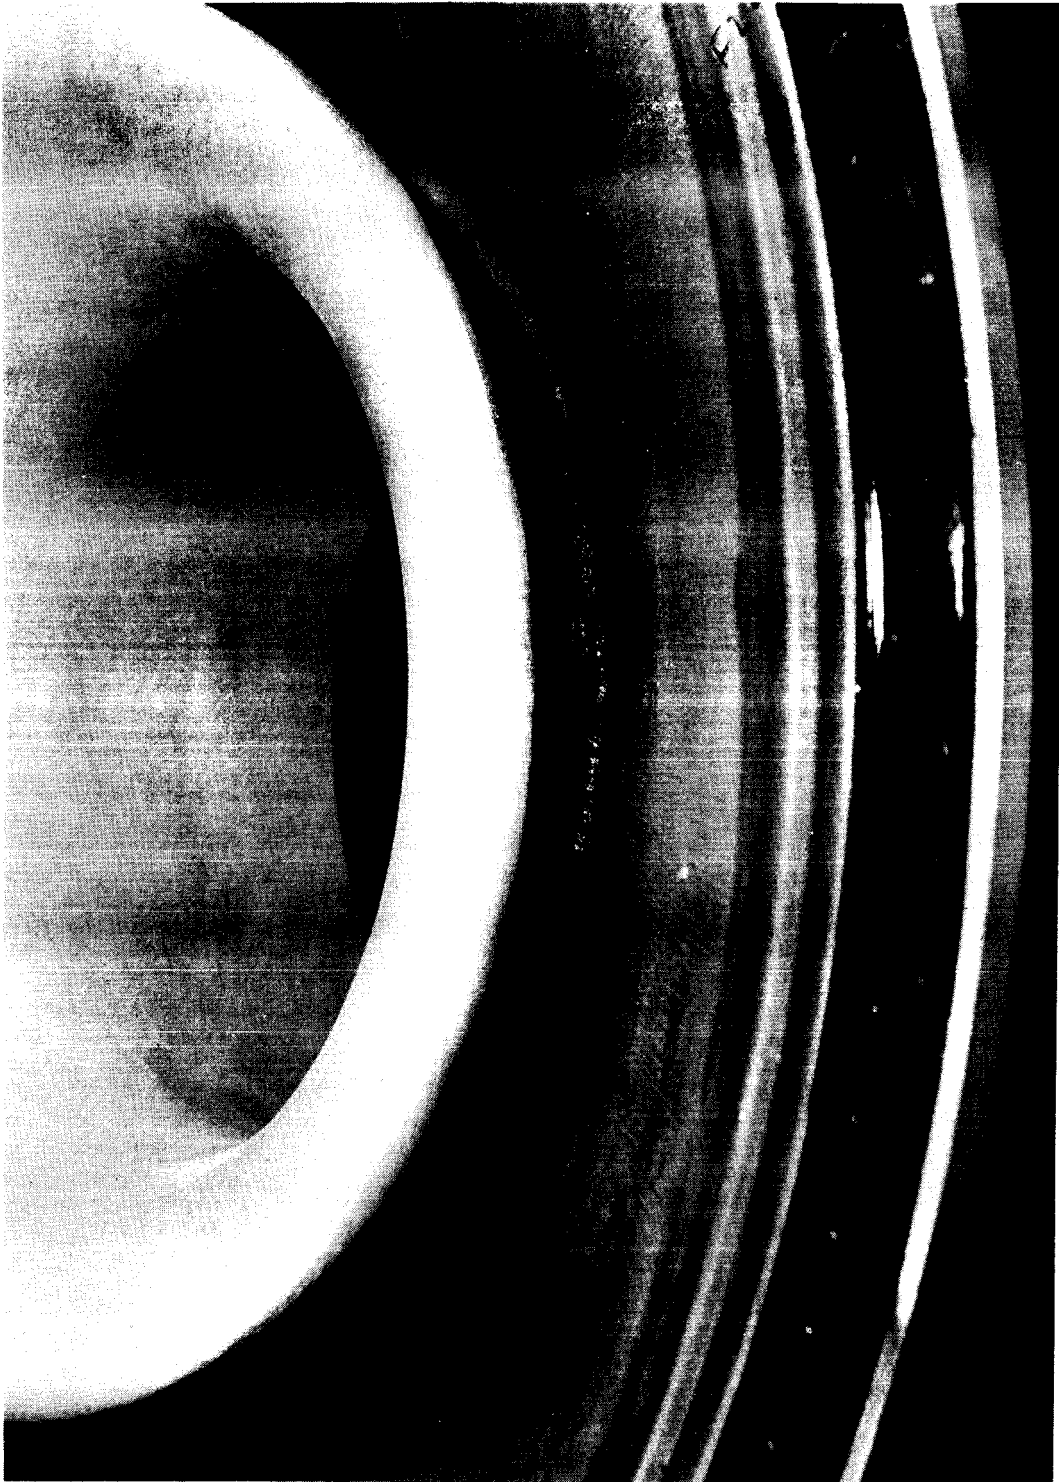
Figure 22

Nozzle Entrance Section During IBT-100 Application

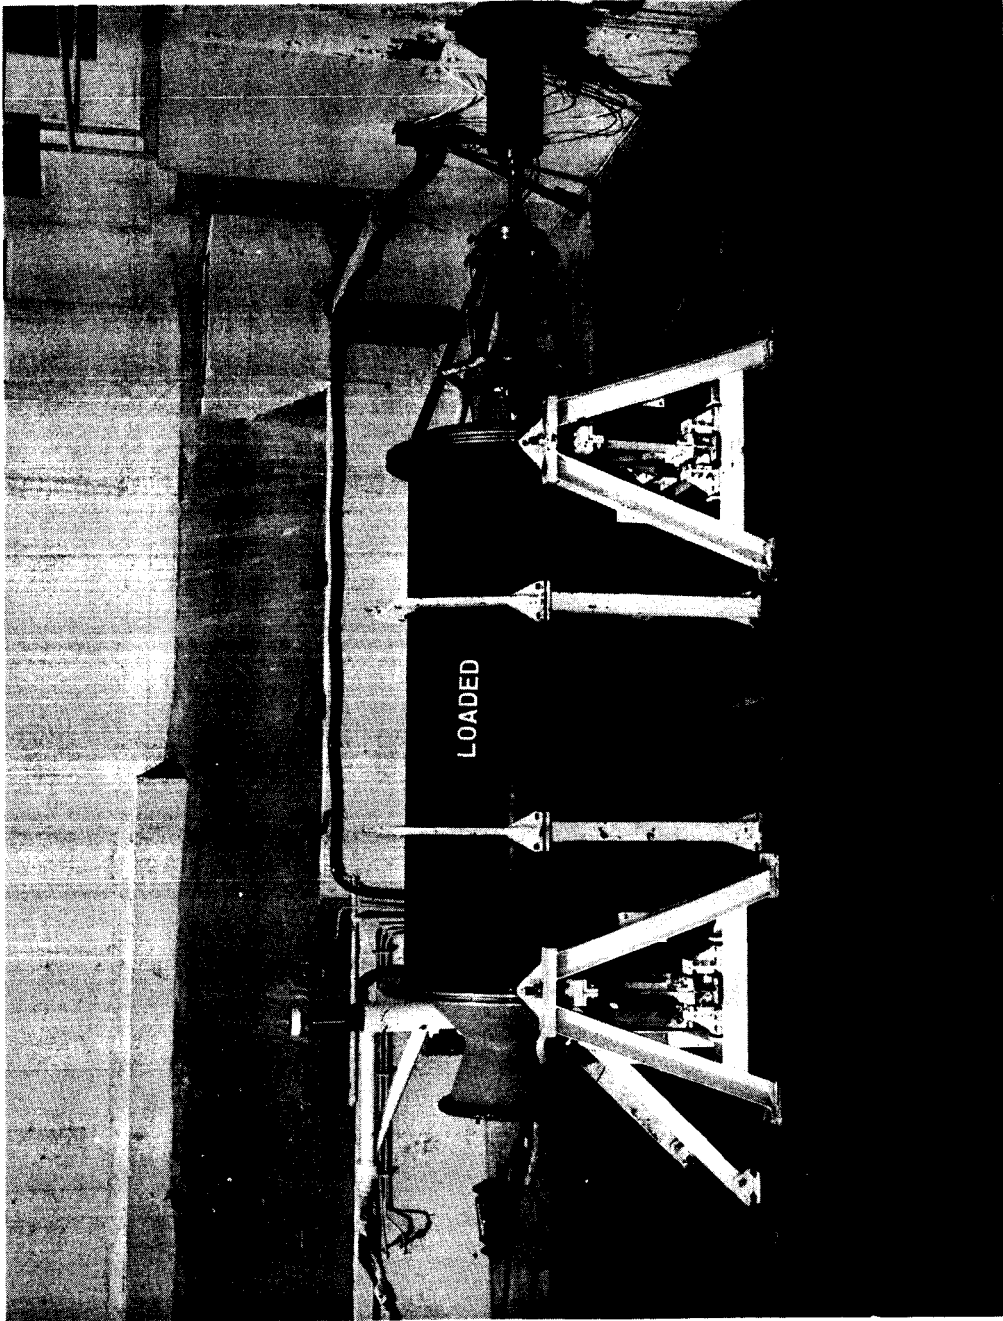
Figure 24

Motor 44-SS-4 in Test Fixture

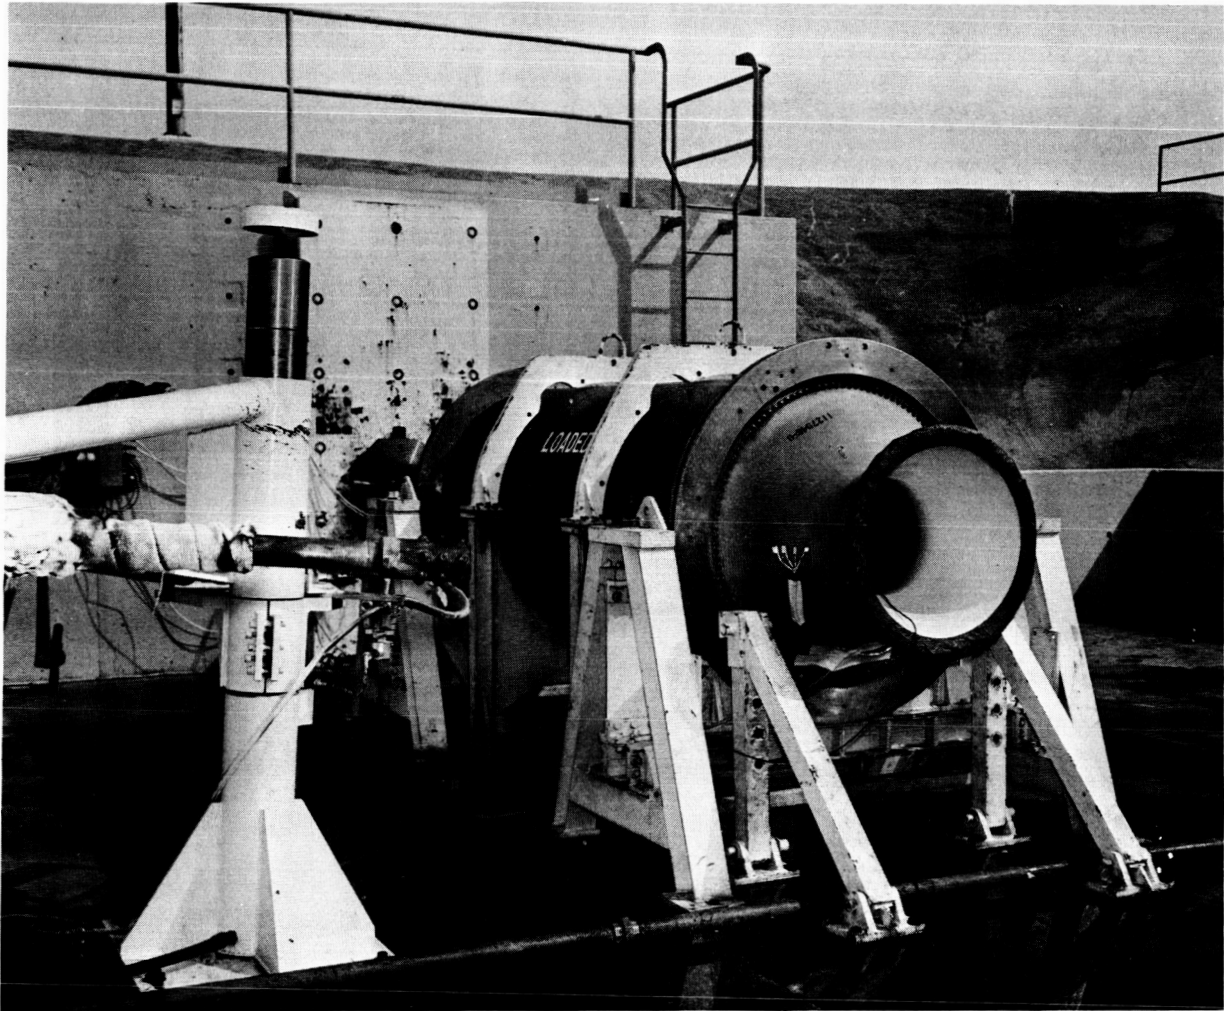
Figure 25

Prefire View of Motor 44-SS-4 Nozzle, 45° Aft
